Office of the Auditor General  
Performance Audit Report

**Physical Security and Environmental Controls  
Over Information Technology Resources**

Department of Technology, Management, and Budget

December 2015

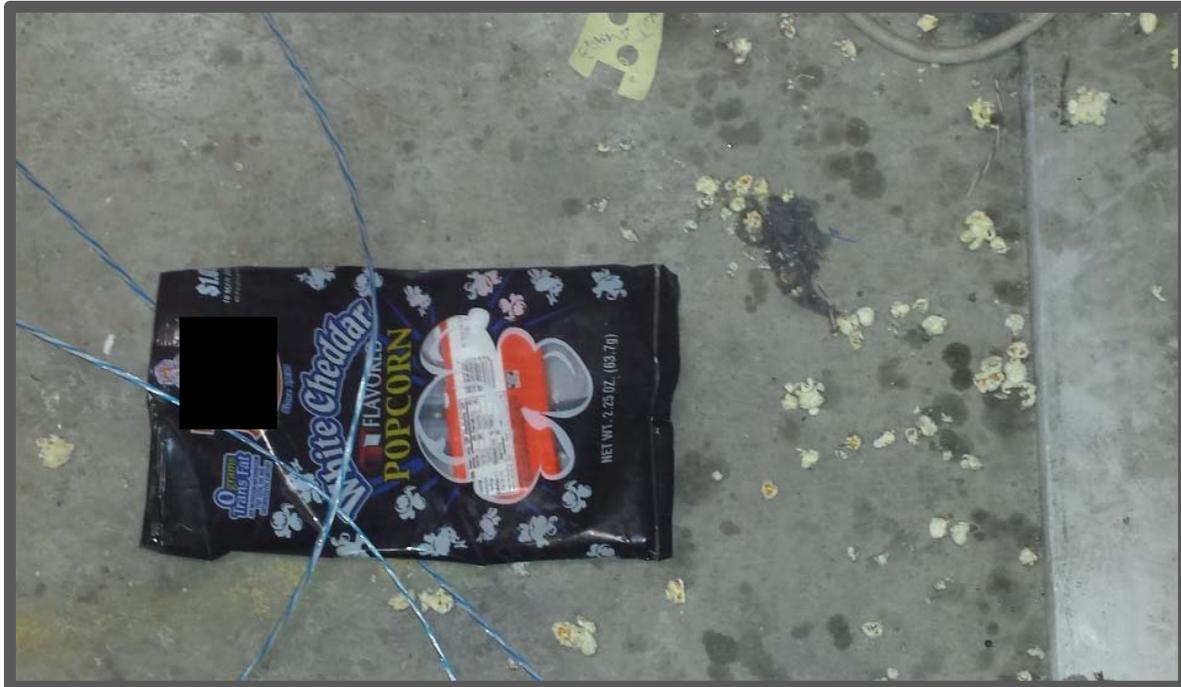
Example of a lack of cleanliness and evidence of food in a TR.

*DTMB agrees with the recommendation. DTMB has already started cleaning of the out-of-compliance switch rooms and will establish an MTR/TR cleaning schedule. DTMB will ensure*

*that its policies and procedures expressly prohibit eating and drinking in MTRs/TRs, including posting proper signage, consistent with best practices. In addition, DTMB will modify its policies to prohibit use of MTRs/TRs for general storage, consistent with best practices. DTMB will evaluate MTRs/TRs found to have water hazards; however, most MTRs/TRs are located in leased facilities. MTRs/TRs located in leased facilities will be addressed on an individual basis and equipment will be relocated, if reasonable accommodations can be achieved. DTMB will evaluate fire detection and suppression systems, alarms, and emergency lighting to meet BICSI standards. In addition, DTMB will develop a plan to inspect and correct, if necessary, all MTRs/TRs to ensure that equipment has proper grounding and surge suppression.*

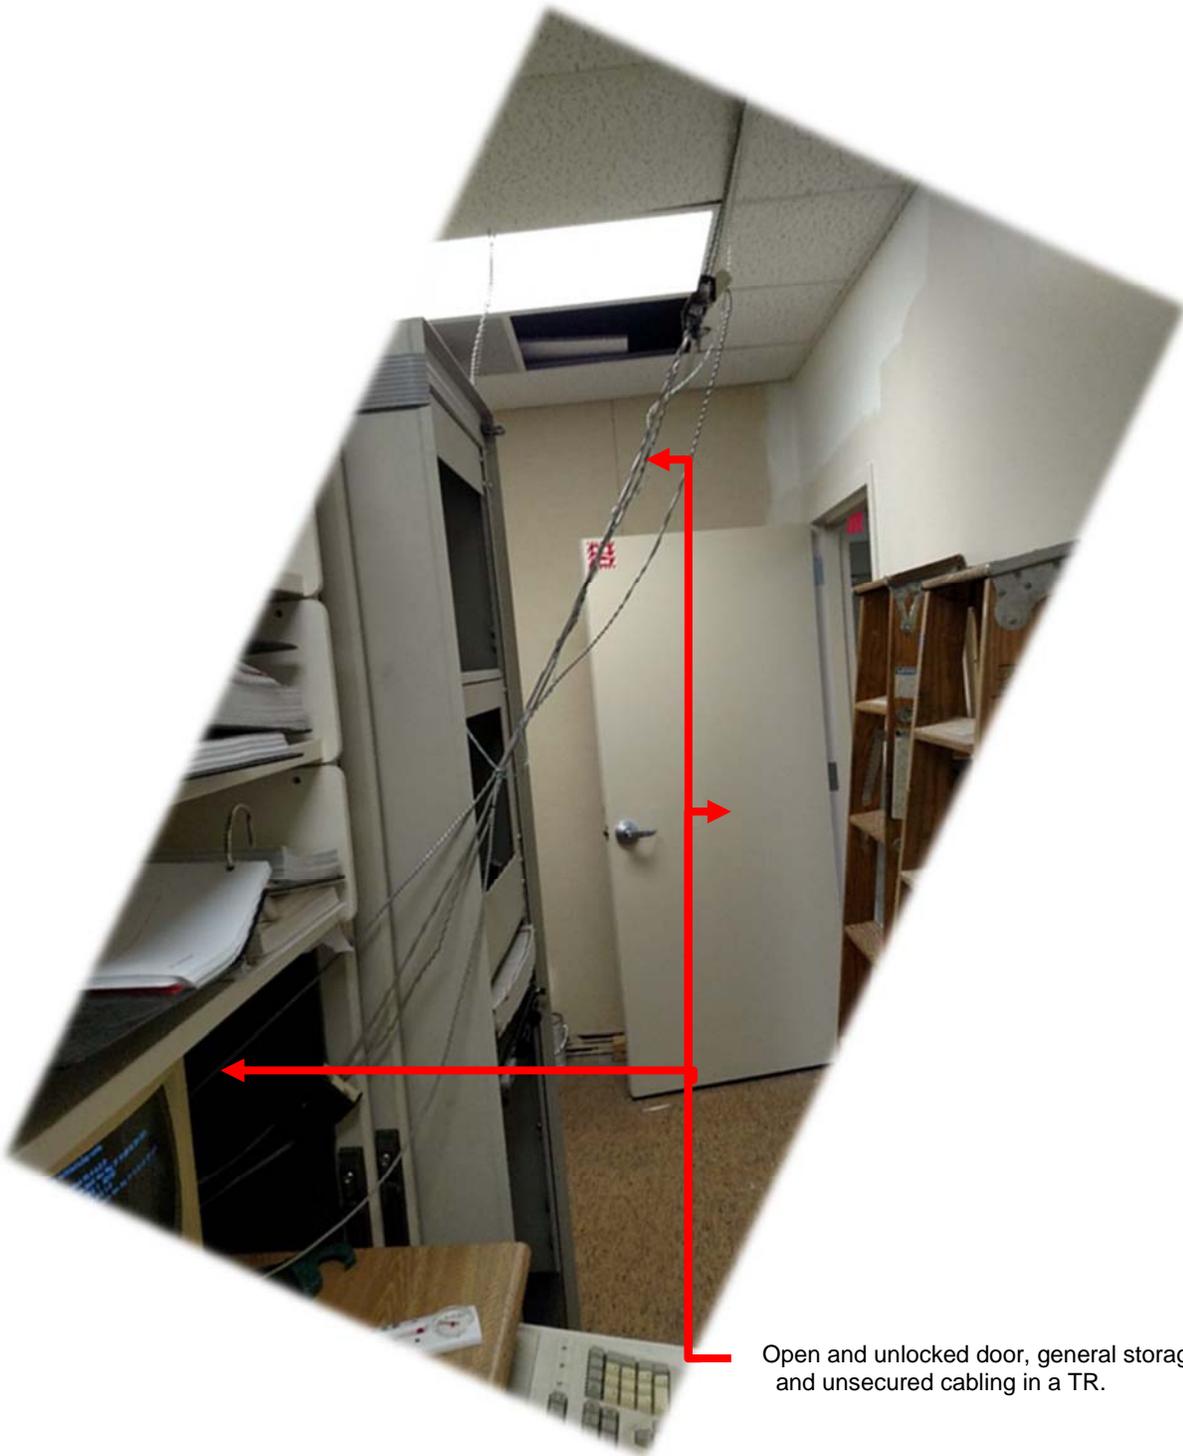
Open and unlocked door, general storage, and unsecured cabling in a TR.

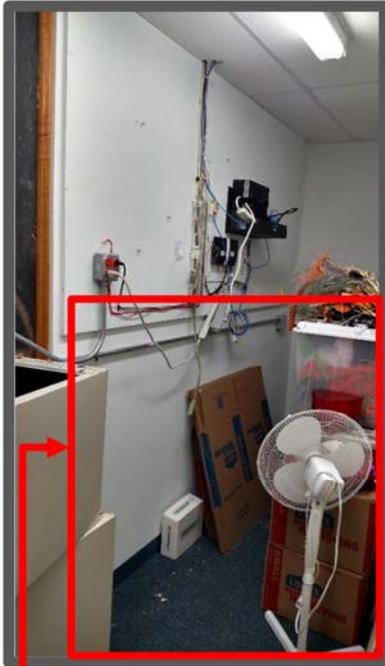
Exhibit 1 presents examples of items we observed. BICSI TDMM states that telecommunication spaces should not be used for general storage, which can hinder the work of IT staff or create a fire hazard. DTMB policy did not address general storage in the hosting centers, MTRs, or TRs.

TR used for storage (boxes and holiday decorations).

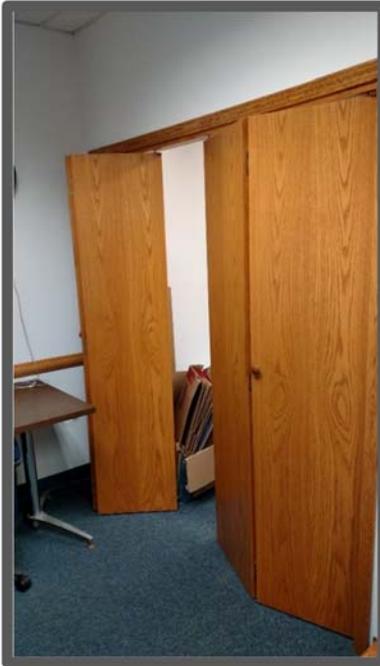
TR with doors that do not lock.

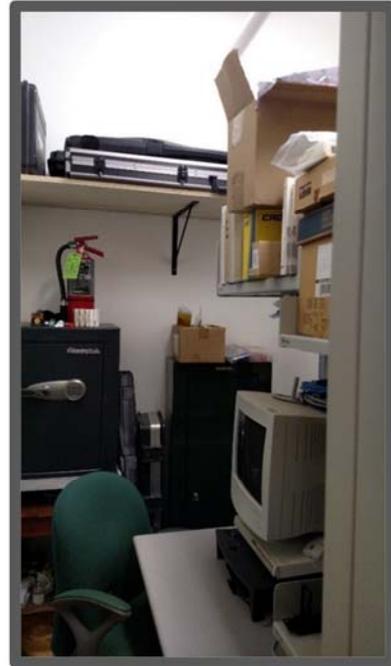
TR with general storage (guns, safes, and ammunition).

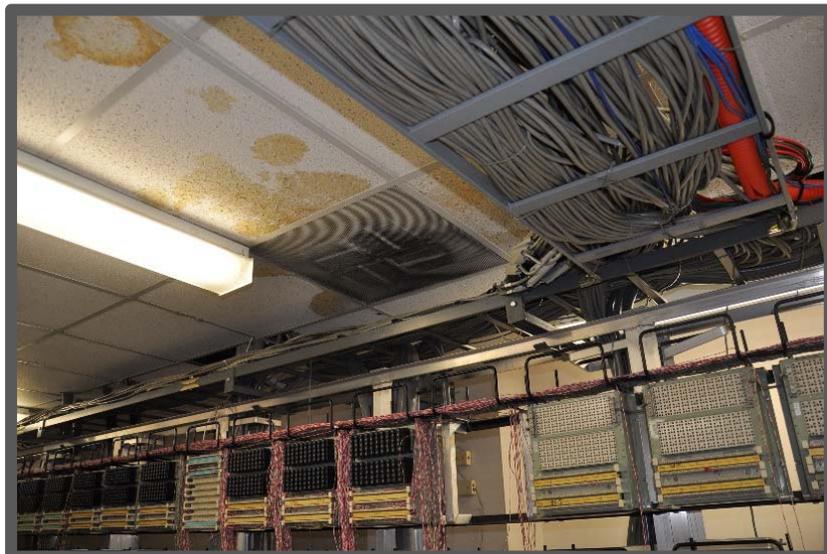
- (1) Equipment in 1 (13%) of the 8 switch rooms and 10 (6%) of the 163 MTRs and TRs was located next to a hot water heater or water softener or was in a basement without a raised floor.
- (2) Two (25%) of the 8 switch rooms and 16 (10%) of the 163 MTRs and TRs were located below restrooms or kitchens and near pipes carrying liquids.
- (3) Two (25%) of the 8 switch rooms and 25 (15%) of the 163 MTRs and TRs showed signs of water damage, such as water-stained ceiling tiles.

Water-damaged ceiling in a switch room above telecommunication equipment.

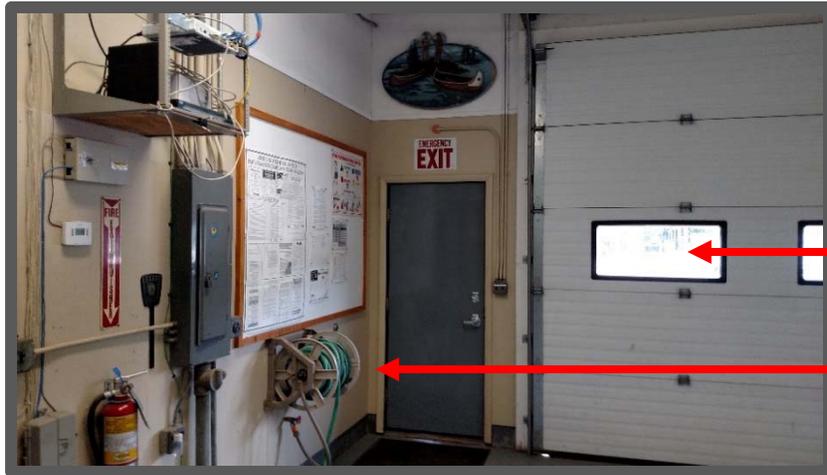
- b. NTSD did not ensure that telecommunication equipment was located in designated MTRs and TRs. Telecommunication equipment was located in garages, break rooms, and general office areas in 12 (7%) of the 163 rooms we visited. DTMB Technical Standard 1345.00.02 requires that an MTR be located in each building and that each floor of the building contain at least one TR.

Telecommunication equipment located in a garage rather than a designated TR.  
Garage doors do not have safety glass. Garden hose near equipment.

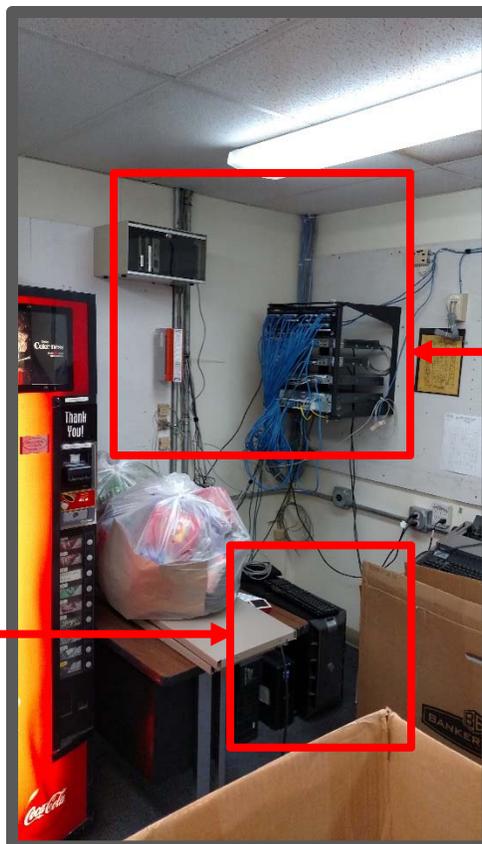
DTMB Technical Standard 1345.00.02 states that carpet should not be used in MTRs and TRs. Carpet increases the risk of static electricity and dust, which could cause a fire or equipment malfunction.

Telecommunication equipment located in a break room rather than in a designated TR.  
Servers are on the floor. Break room has carpeted flooring; general storage (boxes, trash, and typewriter); and food and beverages (vending machine) near the equipment.
